TECHNICAL DATA

MODEL OH-58A

REPORT No. 206-099-788

TITLE GREASED MAIN ROTOR HUB ASSEMBLY
OH-58A HELICOPTER

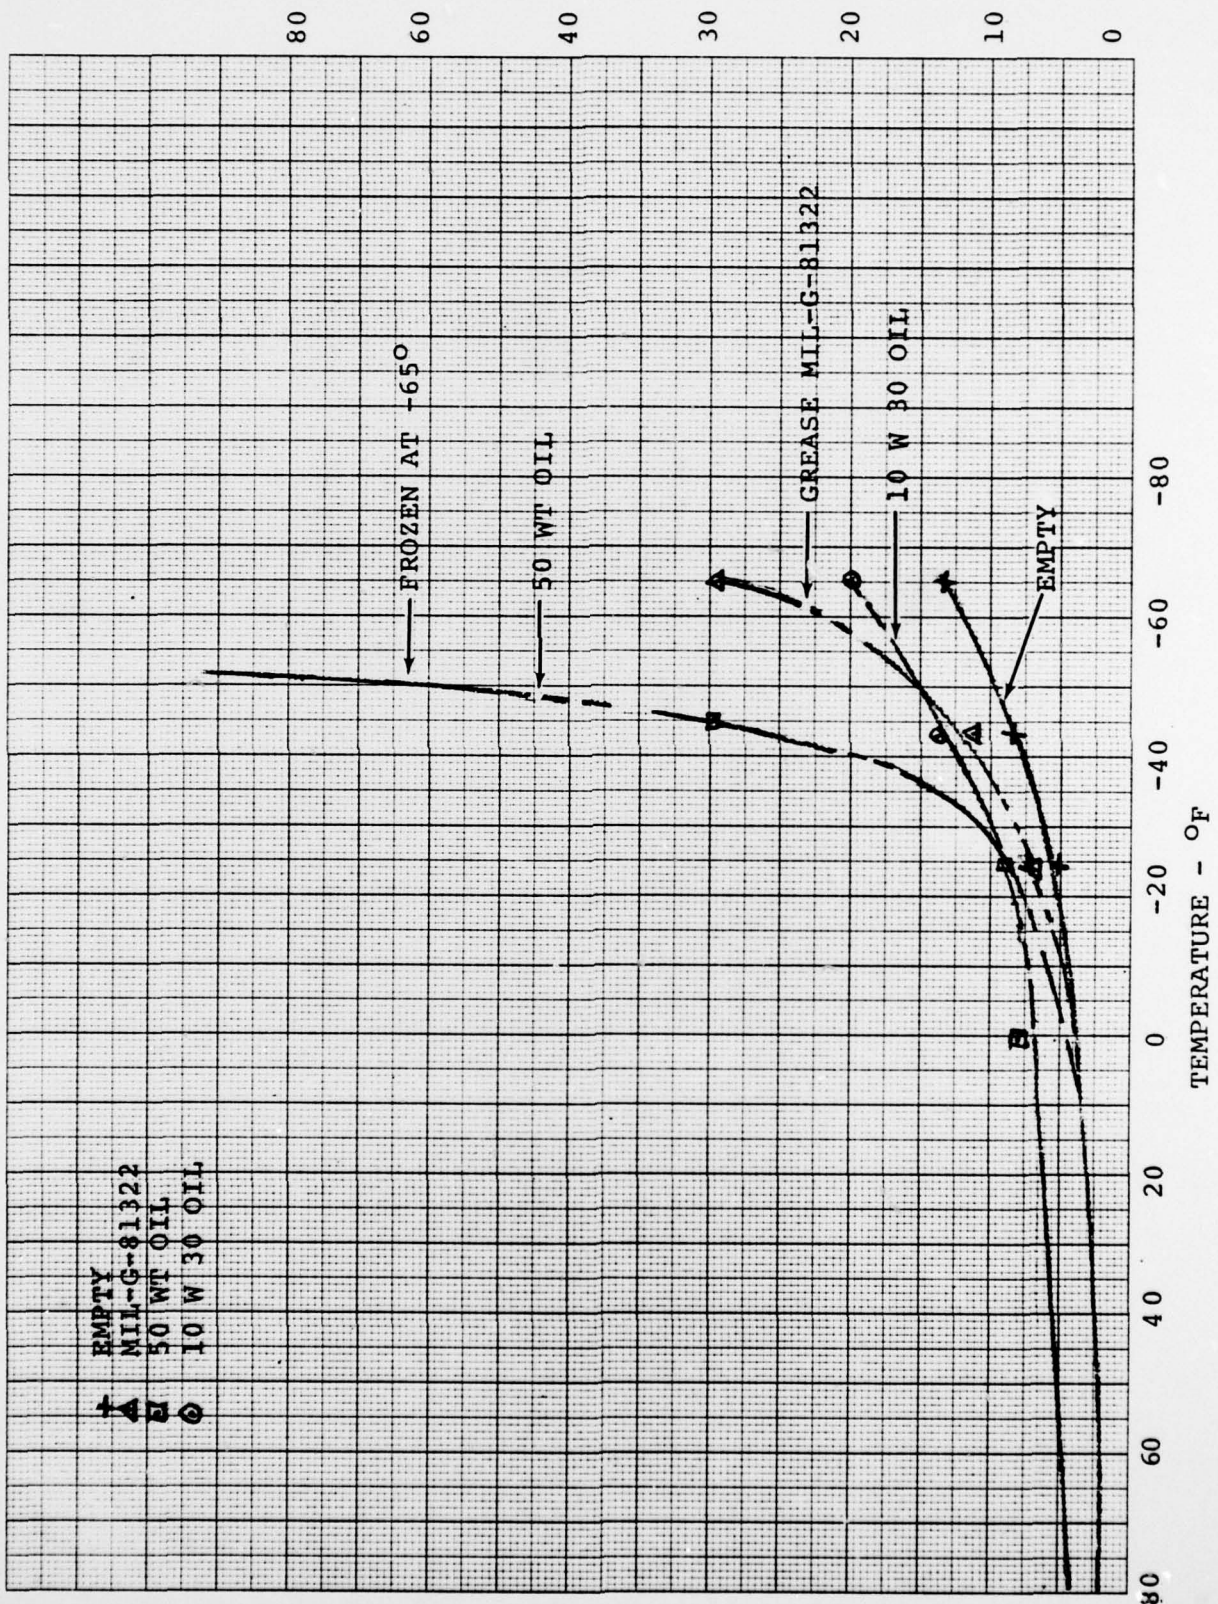
BREAK AWAY FORCE AT PITCH HORN - LB

were performed at 0°F, -25°F, -45°F, and -65°F using SAE 10W-30 Oil, 50 Weight Oil and MIL-G-81322 Grease. One (1) grip of the hub assembly remained empty to provide baseline data for lubricant comparison. The stiffening effect of low temperature on the urethane tension strap, P/N 206-010-105-3, could also be observed. Open containers of each lubricant were placed in the environmental chamber during the test of the particular lubricant in the grip cavity of the hub assembly. The "break away" force required to rotate grips was measured by a spring scale at the pitch horn. A review of the test data is given in Appendix Page A-2 and Page A-3.
